Service Bulletin

Reference Number	NBP-0002
Date	8/22/2018
Product	Digital Pump
Affected Models	NPR6Di & NPR8Di

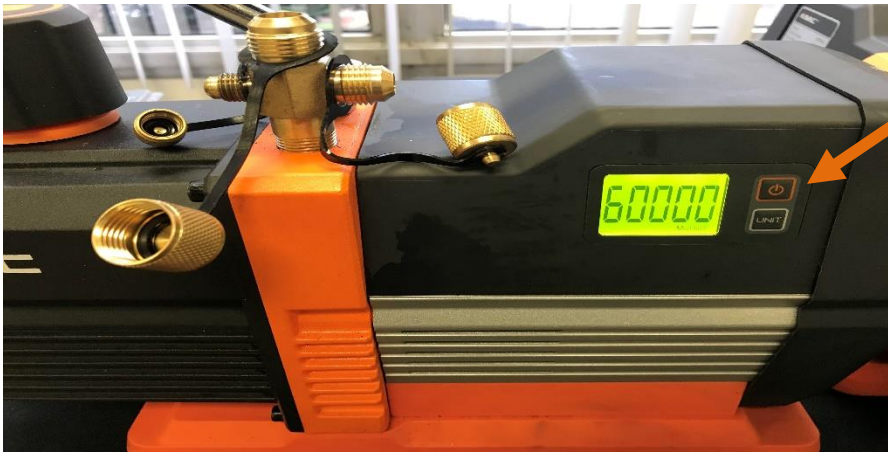
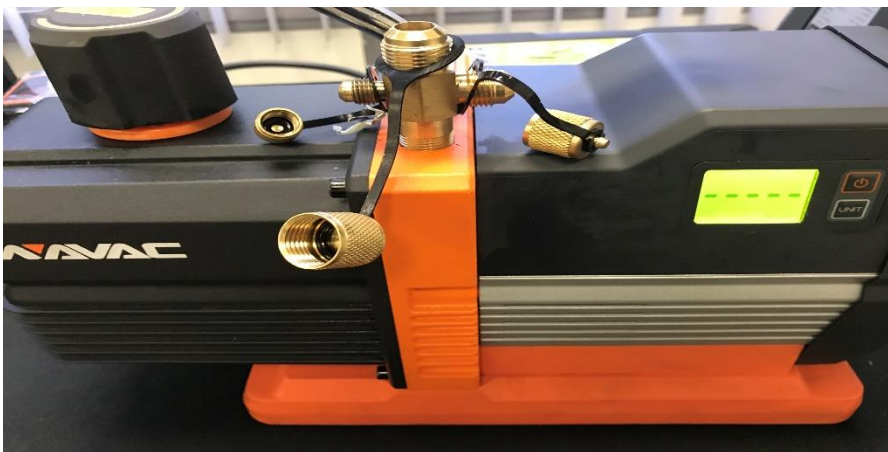
If any residual refrigerant encounters the micron sensor, it may produce erroneous readings.

Issue: Display on micron gauge is reading incorrectly.

Solution: Press and hold the Start/Stop

button for 3 secs to “zero” out gauge.
